COURT OF INQUIRY

***For the purpose of collecting and recording evidence
on the circumstances that resulted in the loss of
HMNZS MANAWANUI off Upolu, Samoa, on 6 October
2024***

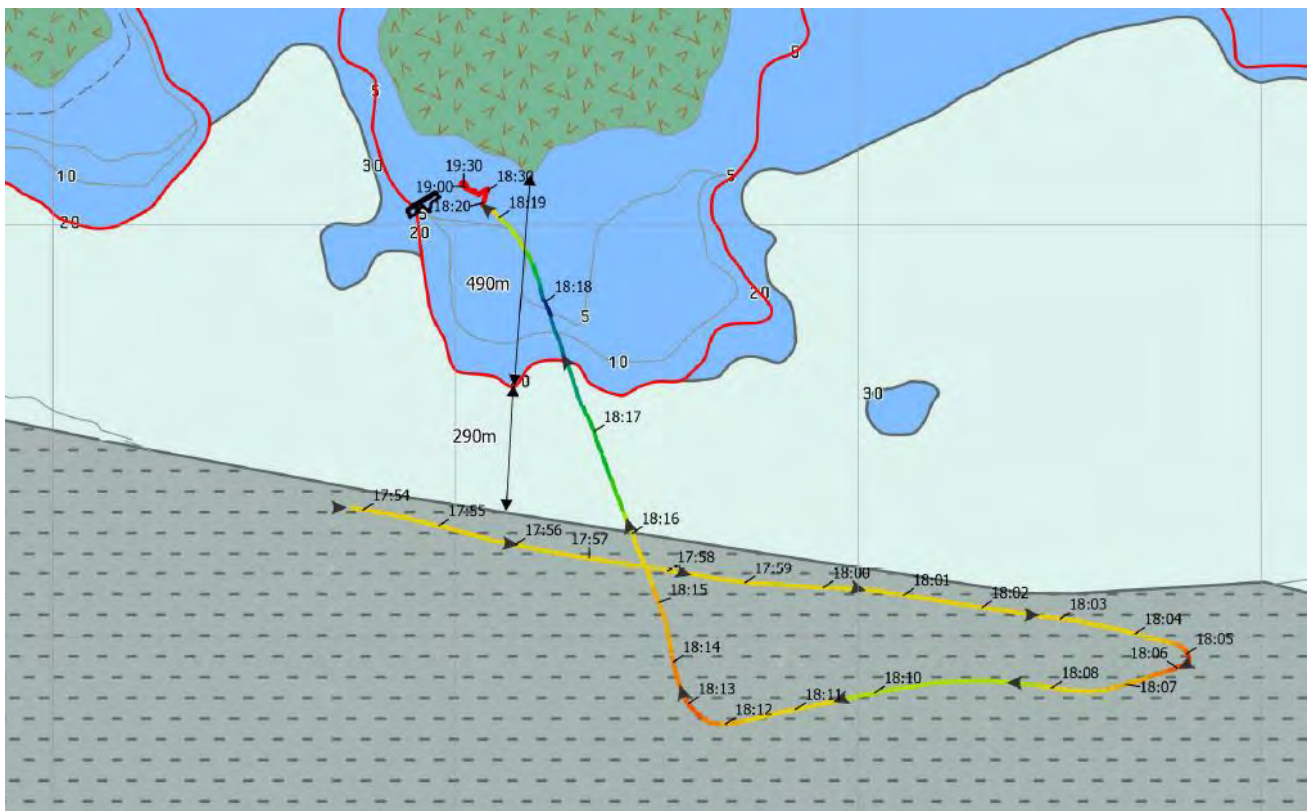
Figure 1: Reconstruction of the track the Ship took in the lead up to the grounding (produced on the basis of Exhibit KX.)

19. These control orders did not result in the Ship stopping, rather the Ship started to accelerate, maintaining an approximate heading of 340° towards the reef. The Ship grounded for the first time at or about 18:17:59 at a speed of around 10.7 kts. The Ship

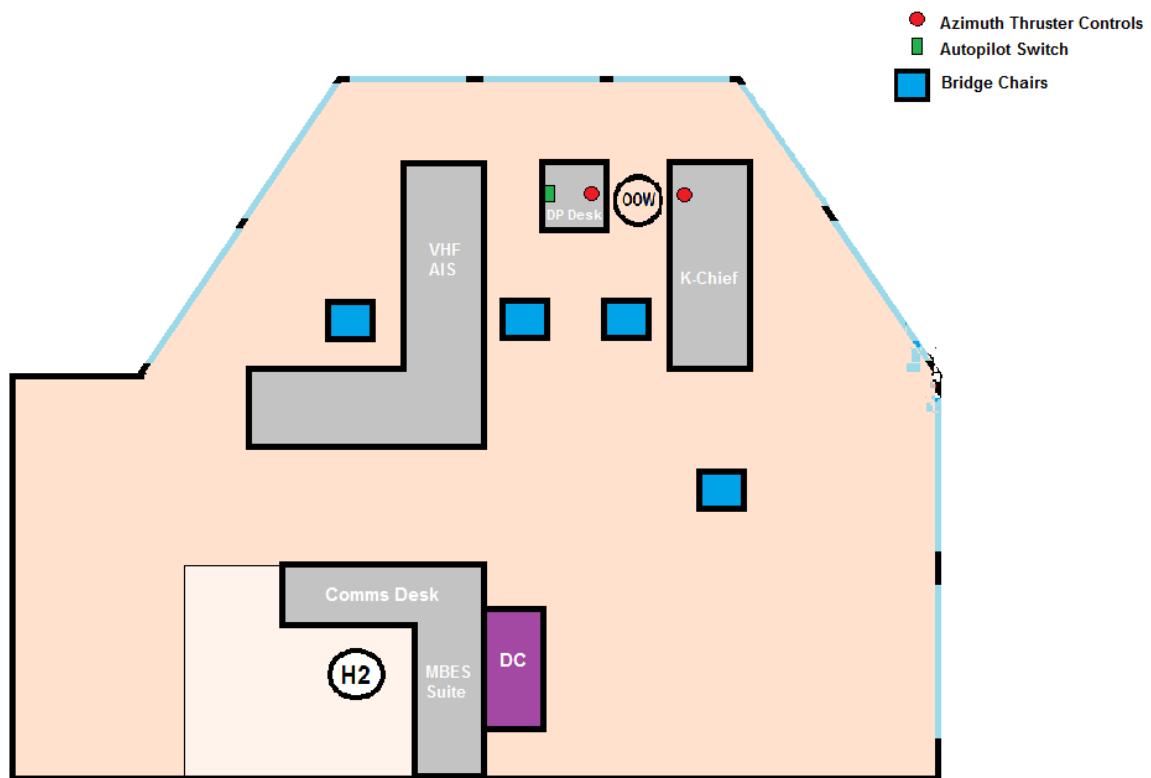
Figure 2: Diagrammatic layout of HMNZS MANAWANUI's Bridge based on exhibit J

21. The direct cause of the grounding has been determined as a series of human errors in that the Ship was put on a heading towards land and the autopilot mode was not disengaged to enable the Ship to turn in an easterly direction. Remaining in autopilot resulted in the Ship maintaining a course of 340° toward land, until grounding and eventually stranding.
22. The correct initial actions for an azimuth thruster failure were not initiated upon realising that the Ship was not responding to the planned starboard turn, the first action being to take the Ship in hand, which means to take the Ship out of autopilot mode.
