OIA-2024-5001

RNZN MTG MINUTE 33/2024

21 May 24

FLEET NAVIGATING OFFICER'S INITIAL INCIDENT REPORT FOR ALLISION AT DEFENCE ARMAMENT DEPOT – KAURI POINT INVOLVING HMNZS TE KAHA – 16 MAY 24

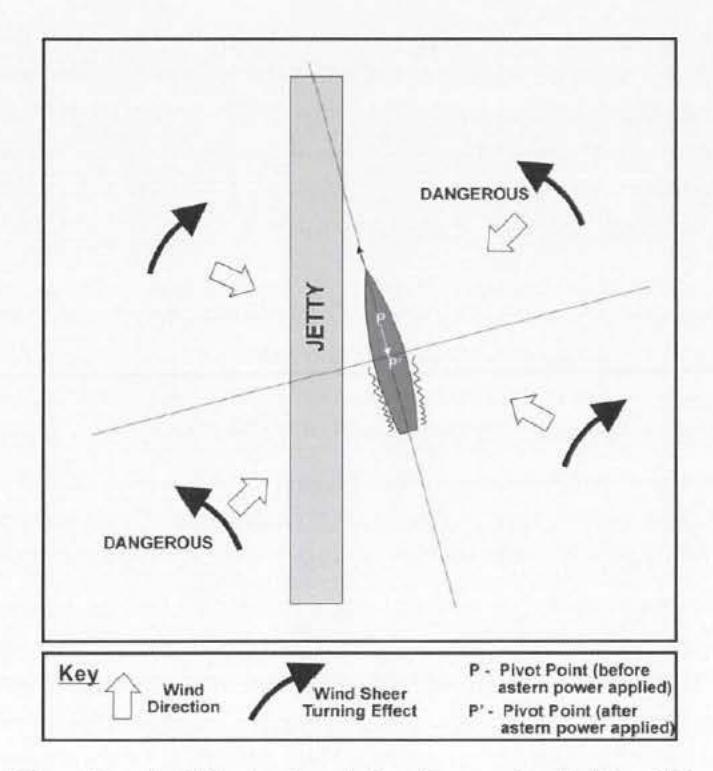
Figure 2: Wind Sheer Turning Effect, when Astern Power Applied to a Ship with Headway

- a. Wind Sheer Moment of Inception. Inspection of Figure 2 shows that as soon as astern power is applied to a ship making headway, the pivot point moves aft to the mid-point of the ship. When this occurs, instead of the bows seeking the wind, in ships with a balanced superstructure the wind sheer contributes to turning the ship beam-on to the wind.
- b. Wind Sheer Most Dangerous Quadrants. Further inspection of Figure 2 also shows that, in common with the empirical experience of many shiphandlers, a wind on the inboard quarter or on the outboard bow are by far the most dangerous as they institute a wind sheer turning effect towards the jetty. In these circumstances, the best action is to apply outboard helm and start a gentle swing away from the jetty, before applying astern power.

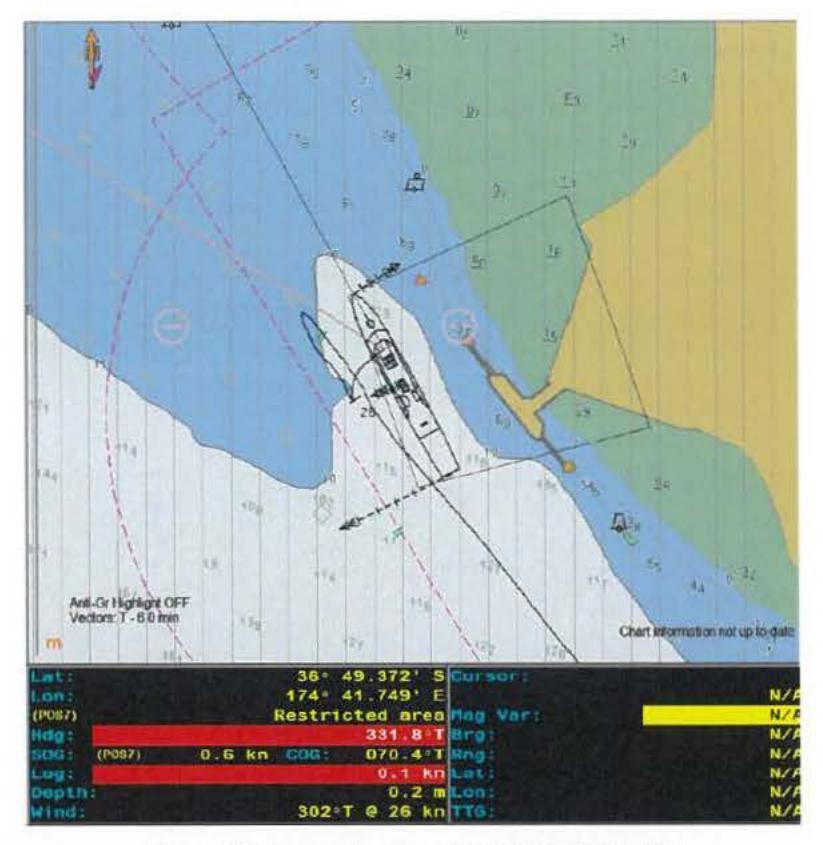
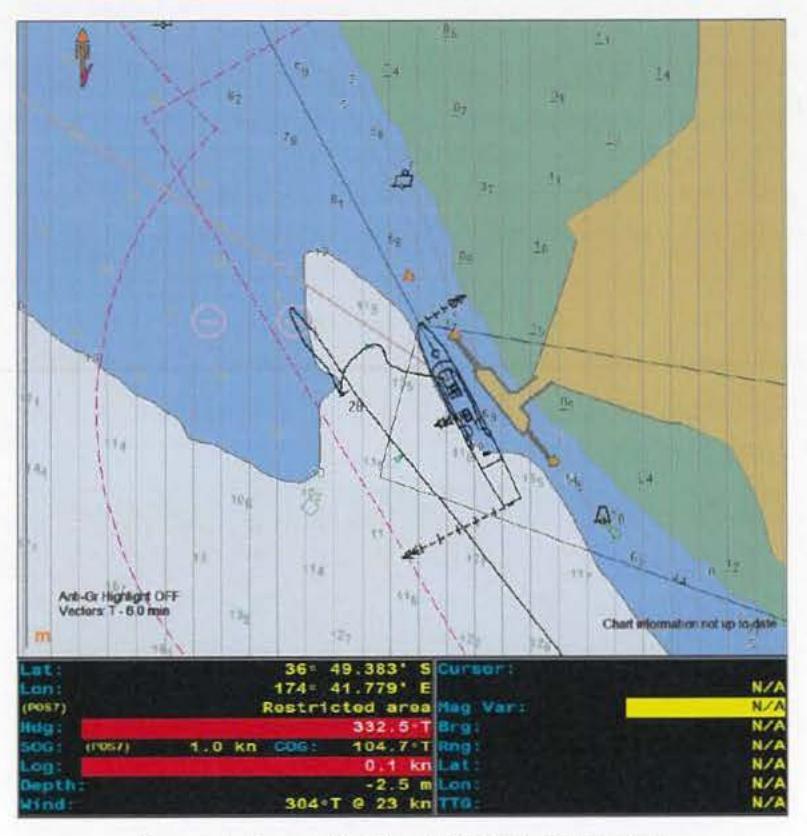
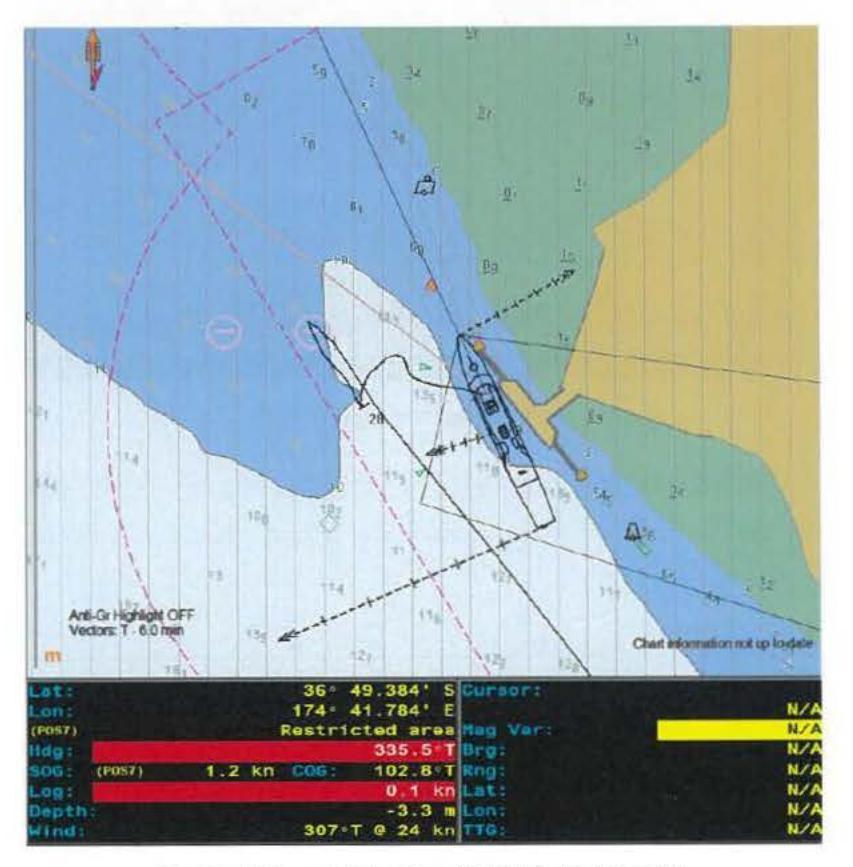
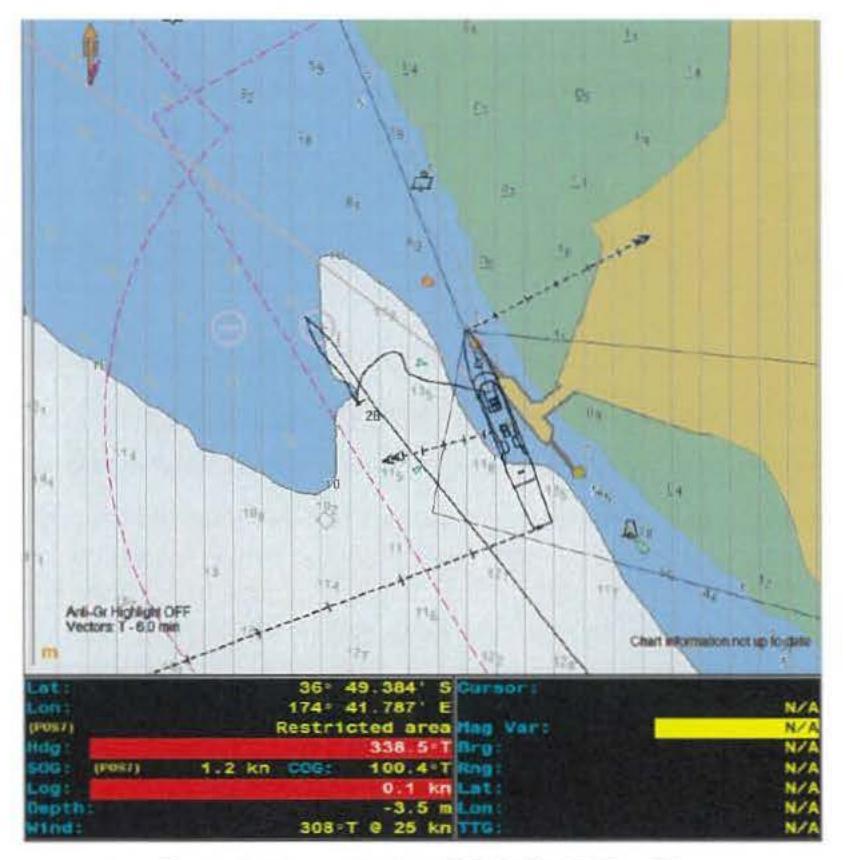
b. TEK's Ship's Log and Navigation Record Book are both scant of details. Additions by the OOW are insufficient to create any narrative or understand the sequencing of events³.

37. As seen in Figures 3 through 6, the bow and stern vectors dramatically increased in speed (represented by growing length) as sternway increased. Though the initial movement of the bow to starboard is almost certainly because of wind sheer, part of this bow movement was possibly exasperated by the tugs; reportedly only the after tug was acting.

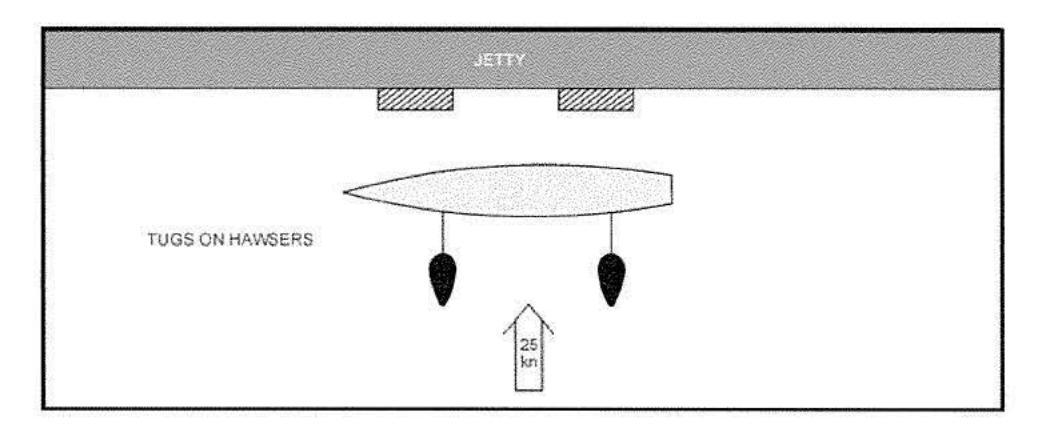
Figure 1: Berthing in Strong Onshore Wind – Tug Controlled Approach

5. Guidance from ref E states that when berthing in strong onshore winds with tugs, the aim is to arrest the ship's forward movement parallel to the berth far enough off to give time for the tugs to take position to windward and manoeuvre to let the ship gently down on to the berth (see Figure 1).
